*ENVIRONMENTAL IMPACT ASSESSMENT
CALYPSO COVE
LONG ISLAND, THE BAHAMAS*

JULY 2023

**ISLANDS
BY DESIGN**

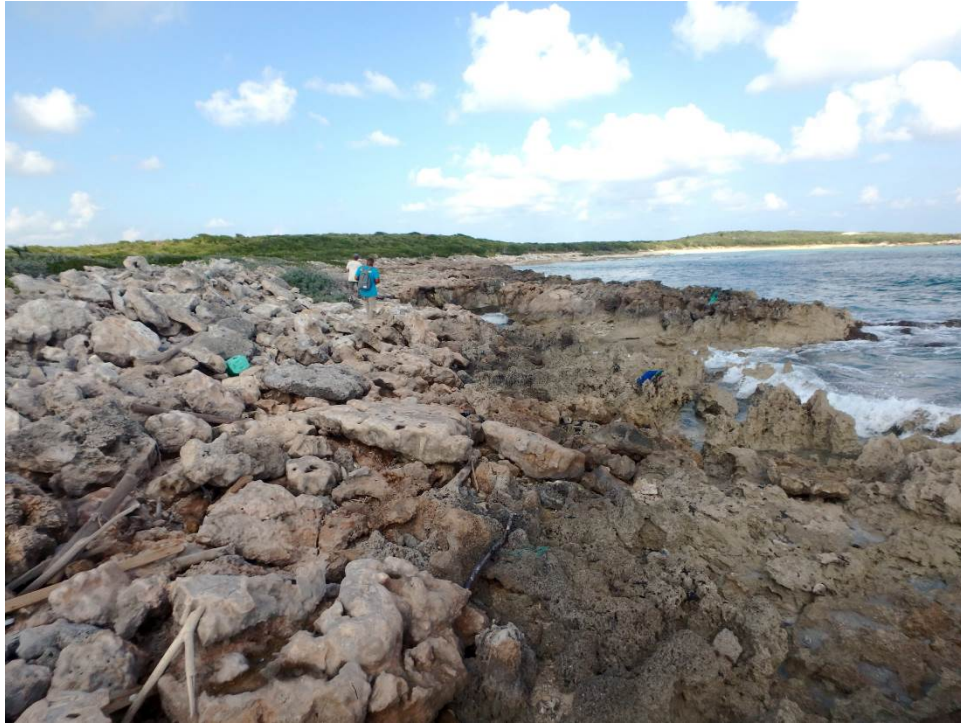
Photo 4-1. Typical Coastal Rock Community on the Southeast Side of the Assessment Area

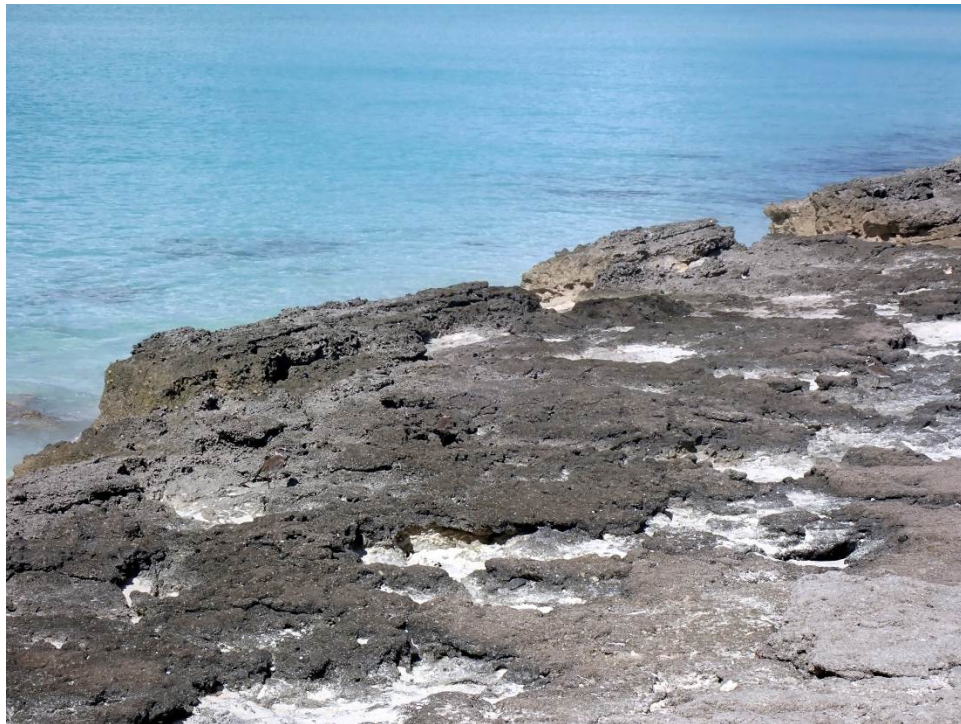
Along the western face of the site, where sea conditions are typically calmer than the southeast exposure, the coastal rock feature is comparatively narrow, is more gently sloped, and is primarily in the intertidal zone. During high tide, this feature may be entirely submerged. Photo 4-2 is representative of this type of coastal rock.

Photo 4-2. Typical Coastal Rock Community on the West Side of the Assessment Area

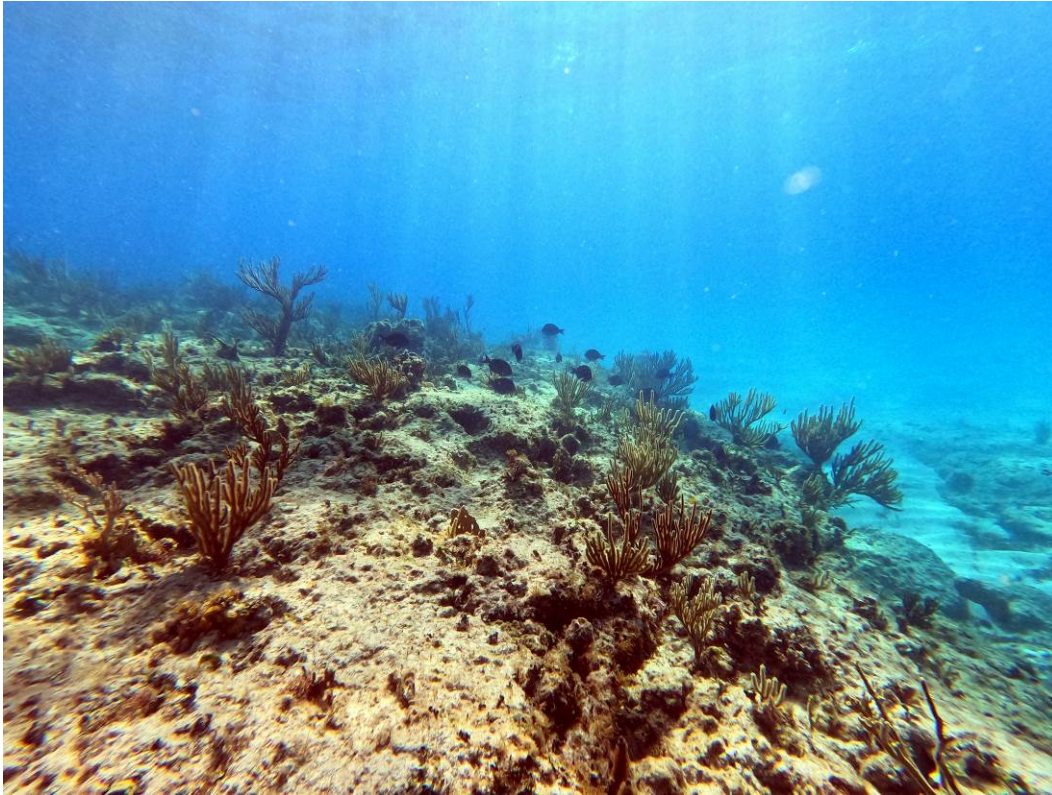
Sea rods and sea plumes, abundant along the east side of the assessment area, extending to lengths of 3 to 6 ft (1 to 2 m) were the dominant sedentary corals in this community. Coral densities varied significantly, but were generally from 5 to 15 percent cover. Juvenile reef-fish, including damselfish, tangs, and wrasses, were abundant in this community. Photo 4-5 is representative of this community.

Photo 4-5. Typical Hardbottom with Macroalgae and Octocorals (February 3, 2023)

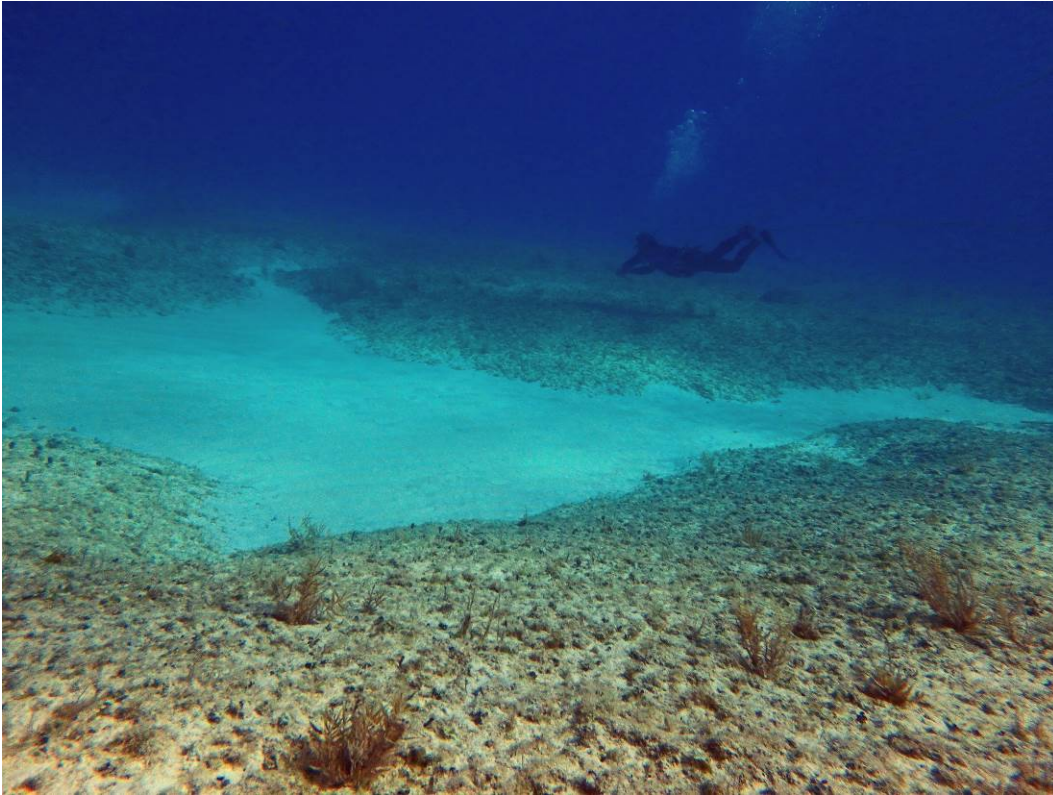
perhaps redistributed by storm conditions and rough seas. Photo 4-6 is representative of this community.

Photo 4-6. Typical Hardbottom with Macroalgae and Sand (February 3, 2023)

From a qualitative perspective, the Hardbottom with Macroalgae and Sand community was rated as Good. No significant natural or human-related impacts were observed.

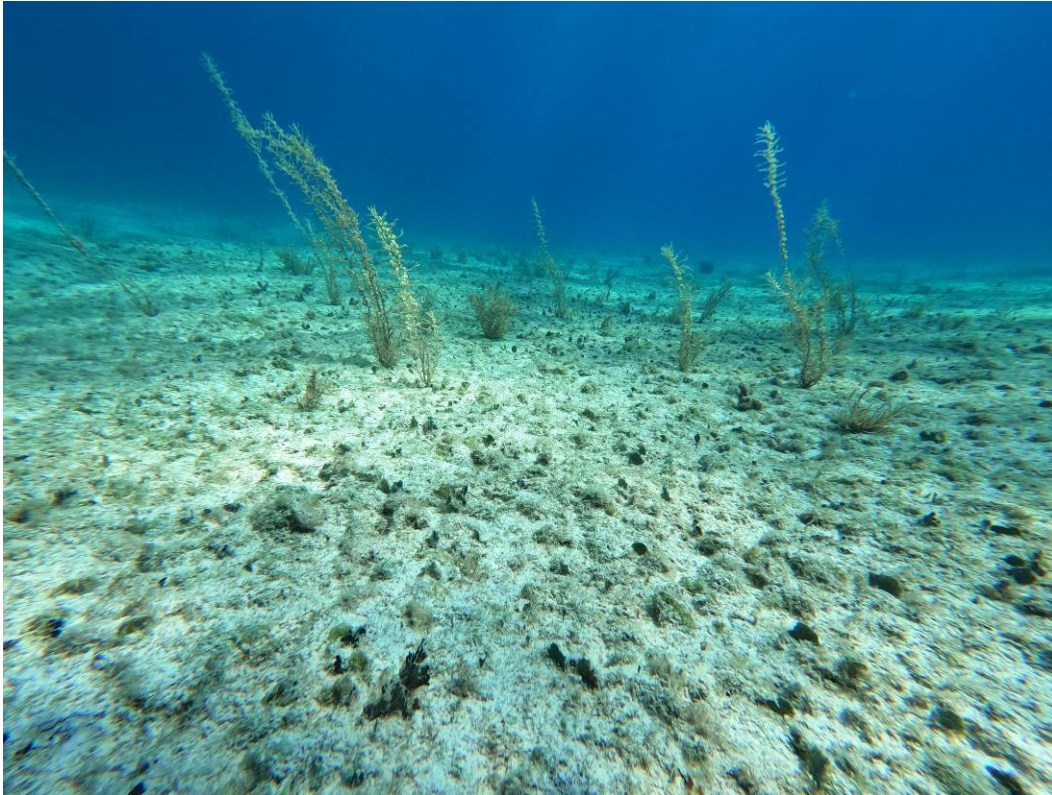
Juvenile reef-fish (e.g., damselfish, tangs, wrasses) and a large school of bonefish (*Abula vulpes*) were observed in this community. Photo 4-8 is representative of this community.

Photo 4-8. Typical Hardbottom with Submerged Aquatic Vegetation (February 3, 2023)

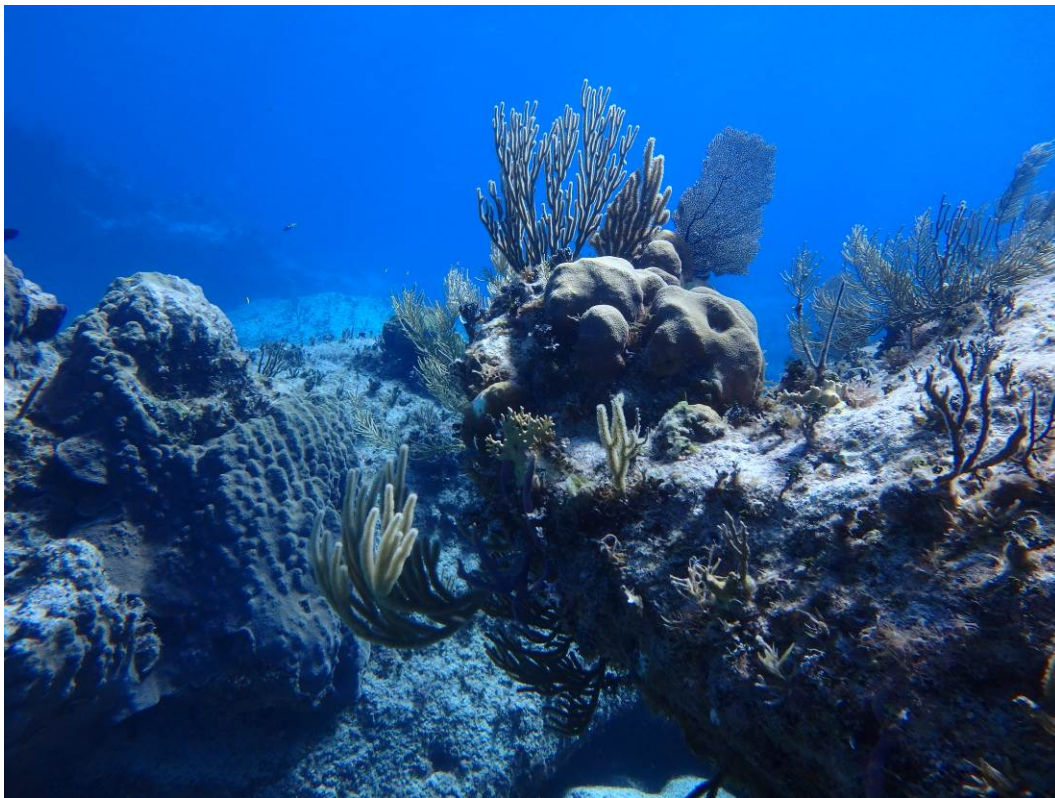
Mostly situated along the southeast edge of the assessment area, the Low-Relief Reef, which was mostly in water depths of 20 to 40 ft (about 6 to 13 m) dropped off steeply toward the south in a community mapped as High-Relief Reef. Stony corals and octocorals, including all of the species present in the Low-Relief Reef community, in addition to pillar corals (*Dendrocygna cylindrus*), elliptical star corals (*Dichocoenia stokesii*), were also present in this community, and were mostly larger and in better condition than in the shallower, Low-Relief Reef. Reef-fish, including damselfish, tangs, wrasses, chubs, snapper, squirrelfish and grouper, were also common in this community, where the substrate had large voids that provided nooks, crannies and abundant surface areas for marine life. Several green turtles and reef sharks were observed in this community. Photo 4-10 is representative of this community.

Photo 4-10. Typical High Relief Reef (February 3, 2023)

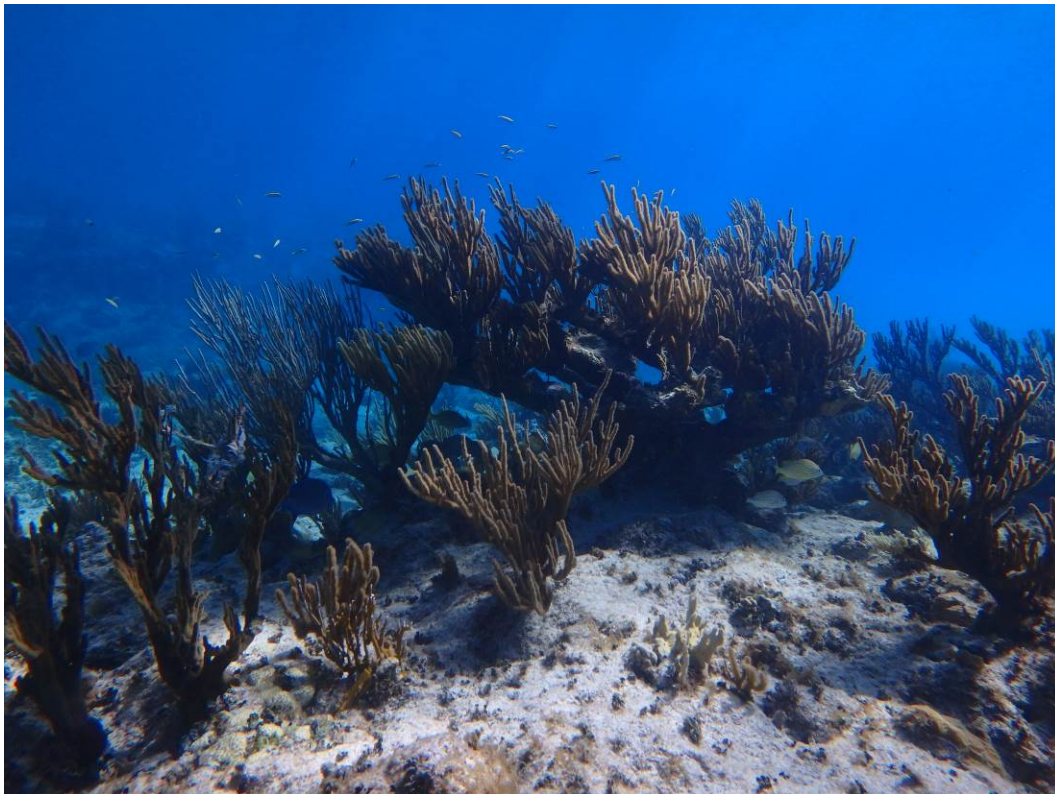
One area in the central part of Folley Bay which is on the east side away from the proposed berthing area stood out from other portions of the assessment area as being an Octocoral Reef. Species diversity was considerably higher than in the nearshore Octocoral-Dominated Hardbottom described previously also in Folley Bay. At this location, where water depths varied from approximately 5 to 15 ft (about 1.5 to 5 m), sea rods (*Plexaura*) were dominant. Stony corals were minimally present, but the foundation upon which the octocoral were growing was largely the skeletons of previously deceased stony corals, including elkhorn (*Acropora palmata*), some of which appeared to have likely been 10 ft (about 3 m) or more in diameter when they were alive. Photo 4-11 is representative of this community.

Photo 4-11. Typical Octocoral Reef (February 6, 2023)

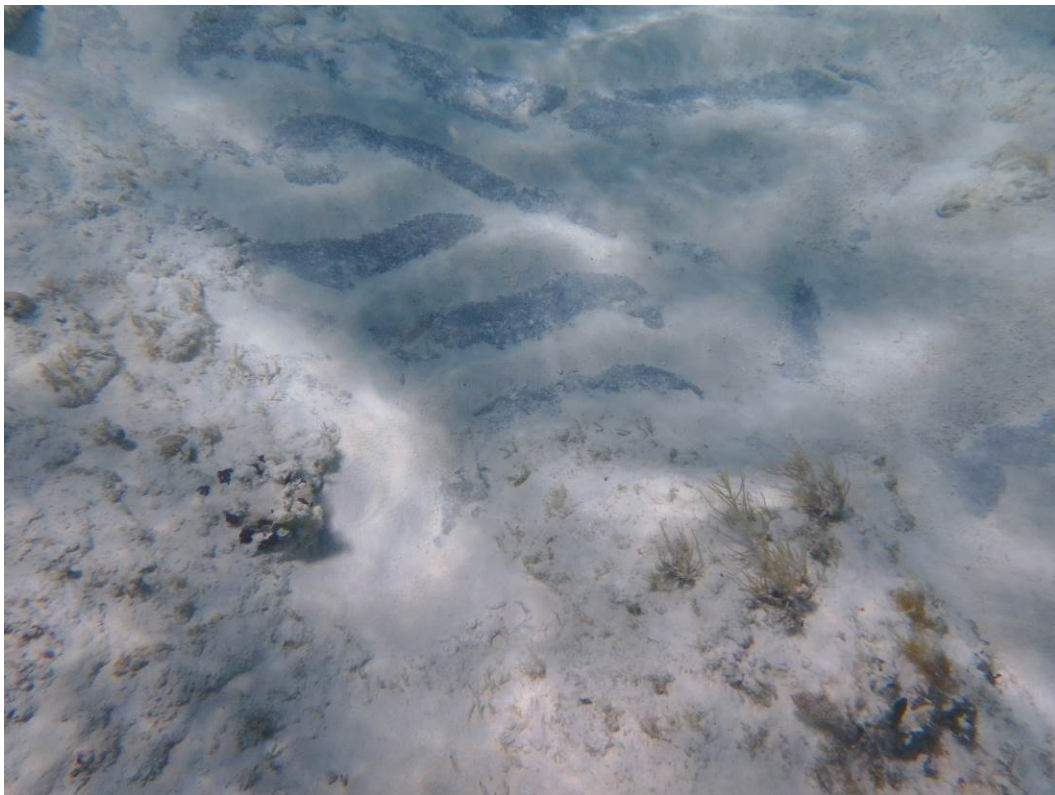
In some areas in the northwestern part of the assessment area, a comparatively thin layer of sand overlaid the Hardbottom substrate. The sandy sediments are likely mobilized during periods of rough seas, creating alternating conditions of exposed hardbottom and sandy patches, when the hardbottom is covered. Some juvenile reef-fish (e.g., mojarra, damselfish, tangs, wrasses) were present, but not abundant, in this community. Photo 4-16 is representative of this community.

Photo 4-16. Typical Sand with Hardbottom (February 5,2023)

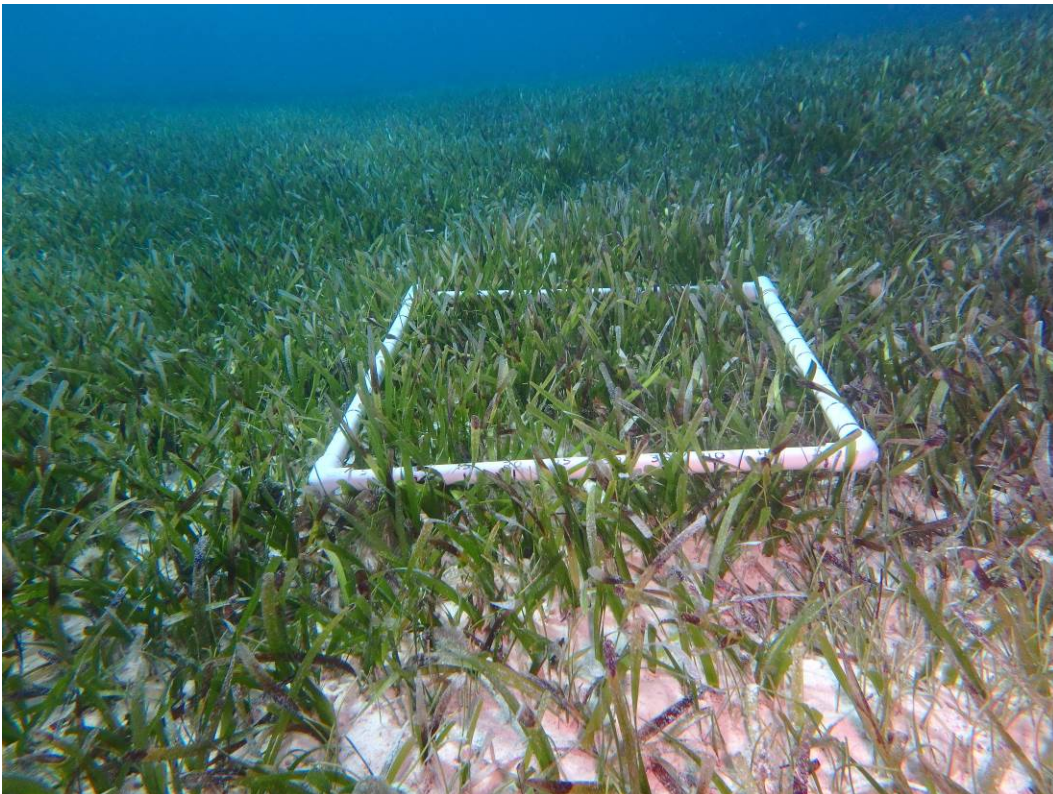
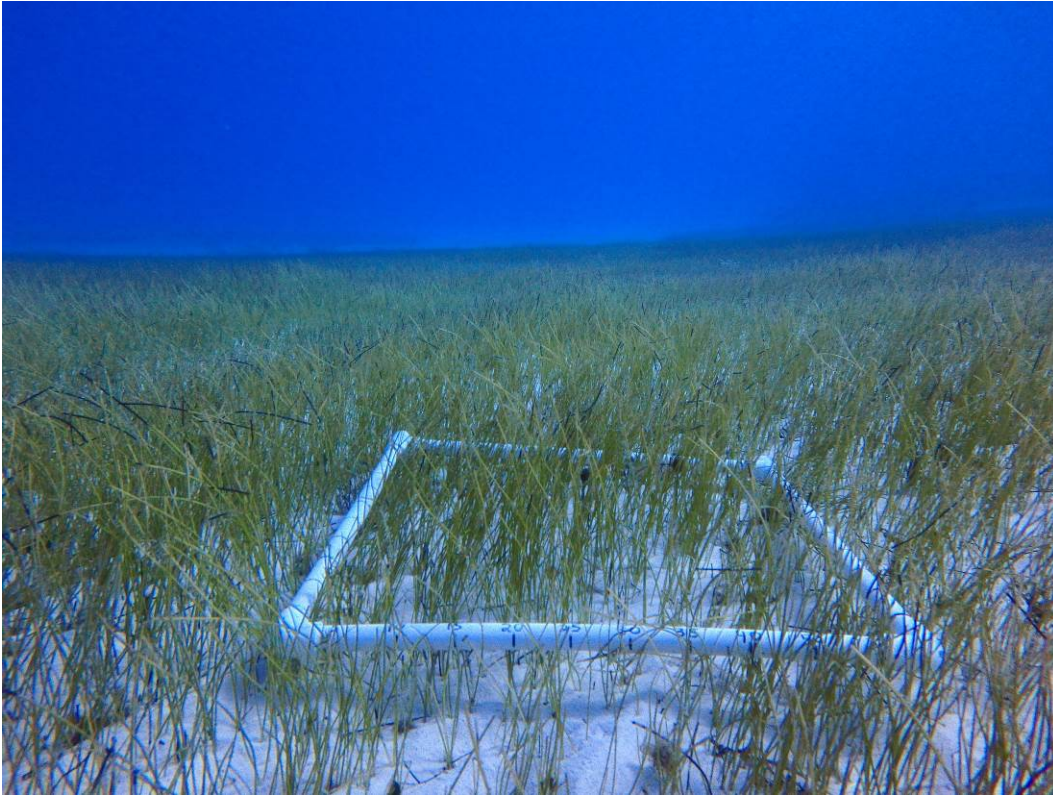
Seagrasses are well documented as being highly productive and valuable as habitat for juvenile fishes, queen conch and other marine life, and for stabilizing sediments. Photo 4-18 and Photo 4-19 are representative of these two types of Seagrass communities described.

Photo 4-18. Typical Dense Turtle Grass in Shallow Water on West Side of Assessment Area (February 4, 2023)

Photo 4-19. Typical Dense Manatee Grass in Shallow Water on Southeast Side of Assessment Area (February 3, 2023)

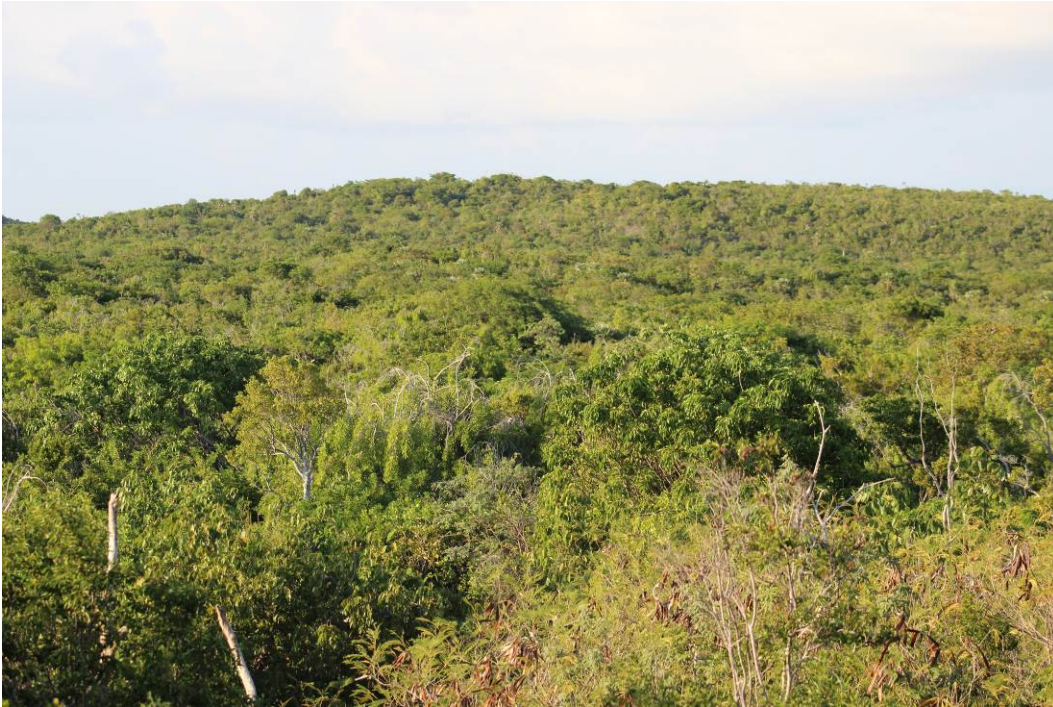
Photo 4-21. Typical Dry Broadleaf Evergreen Forest (December 12, 2022)

The majority of the vegetation within Phase 1, 190 acres (42 percent), can be classified as Dry Broad-Leaf Evergreen Forest (DBEF). This vegetative community consists of dense, closed-canopy forest with a diverse tree assemblage. Photo 4-21 is representative of the typical tree density and canopy closure encountered in this vegetative community.

Except in areas where it abutted disturbed areas, the DBEF community typically began at the landward edge of the coastal coppice and continued up-slope to the height of the land.

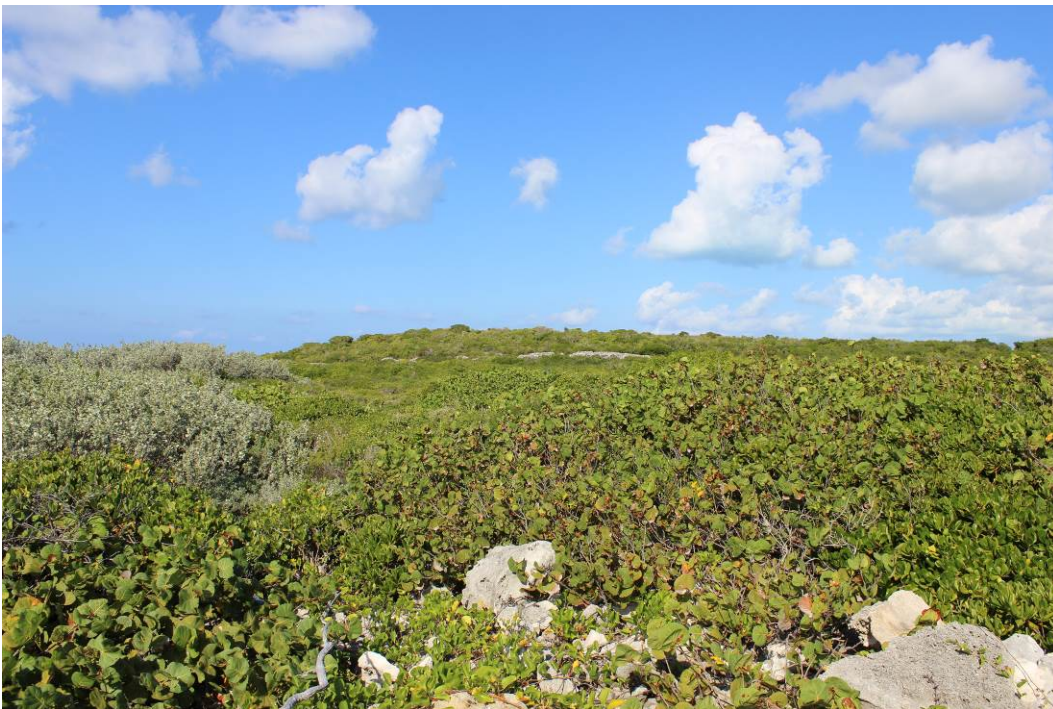
Photo 4-22. Typical Coastal Coppice (December 12, 2022)

Within the overall category of DBEF, areas in close proximity to the shore, where vegetation height and/or species composition was affected by salt spray, were mapped as DBEF-CC (Photo 4-22). This community occupied approximately 66.5 acres (15 percent) of the assessment area. Although the canopy was still enclosed, tree height was lower than in interior areas, and species included those more tolerant of coastal conditions.

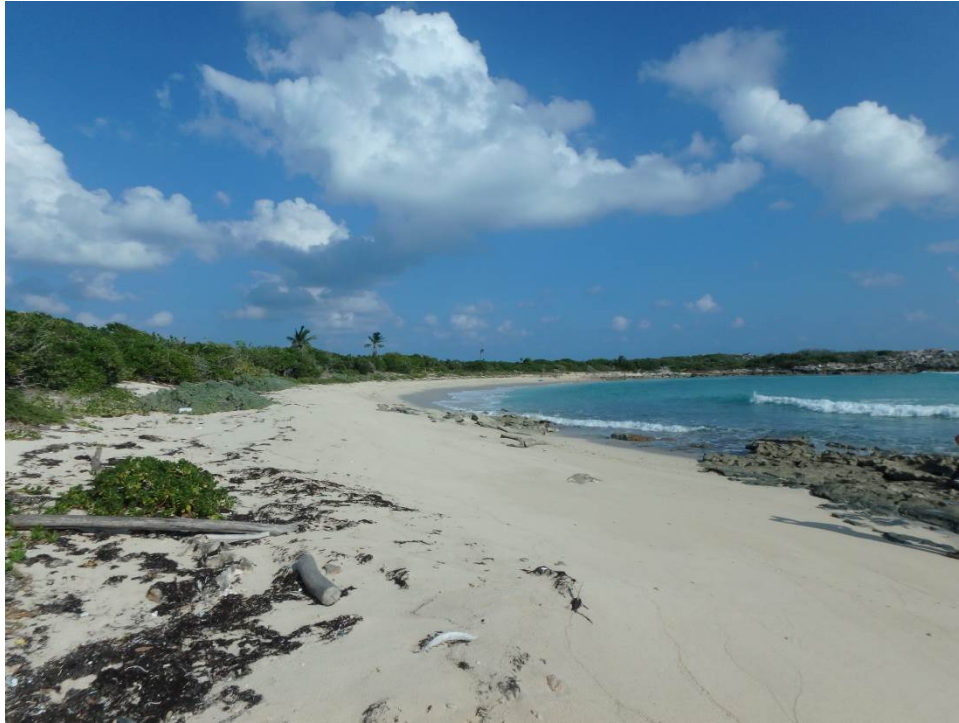
Photo 4-23. Barren Sandy Beach at Folley Bay (December 11, 2022)

Approximately 4,000 linear feet (about 50 percent of the shoreline within the assessment area) consisted of a barren, unvegetated beach. A small percentage of this was located along the northerly stretch of shoreline in Folley Bay (Photo 4-23), where there was little pioneer plant zone or primary dune. The majority of the sandy beach was present on the west-facing portion of the assessment area, extending from the northern property line south to near the southern tip. In this area, except where Australian pines were present, the beach was gently sloped.

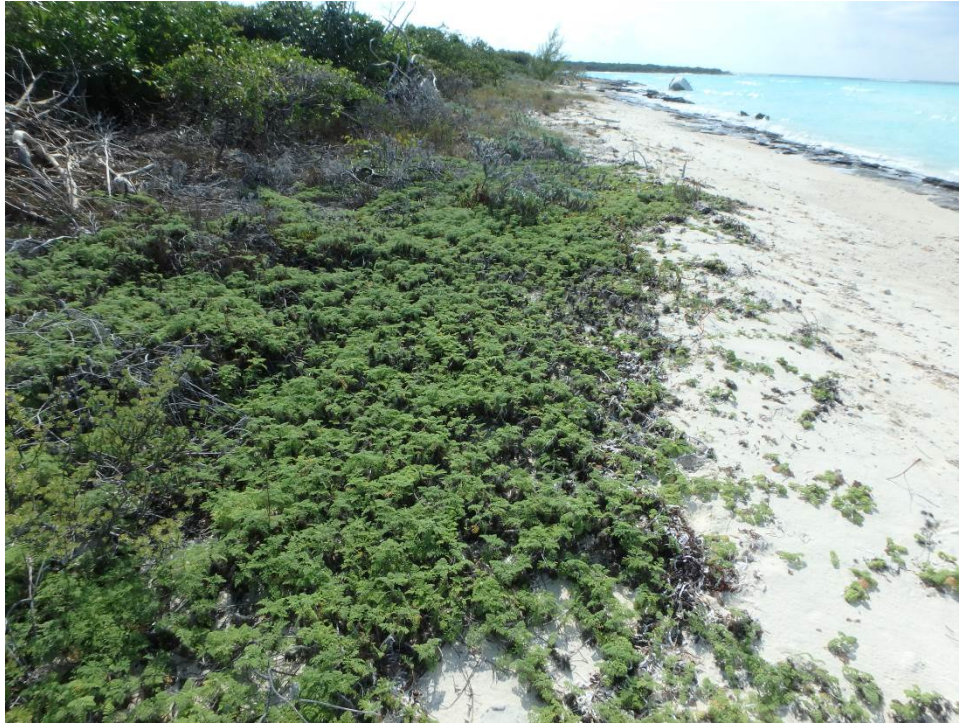
Photo 4-24. Typical Sandy Beach with Established Pioneer Plant Zone (December 11, 2022)

Landward of the Barren Sand was a transition zone to pioneer plants (Photo 4-24), then a well-established primary dune of varying height and a further transition to Sand Strand community. Storms redistribute the sand, alternatively eroding beaches in some areas and accreting it in other areas. On the western side of the project, sand appears to cover an underlying, gently sloping, coastal rock feature, alternately burying and exposing it.

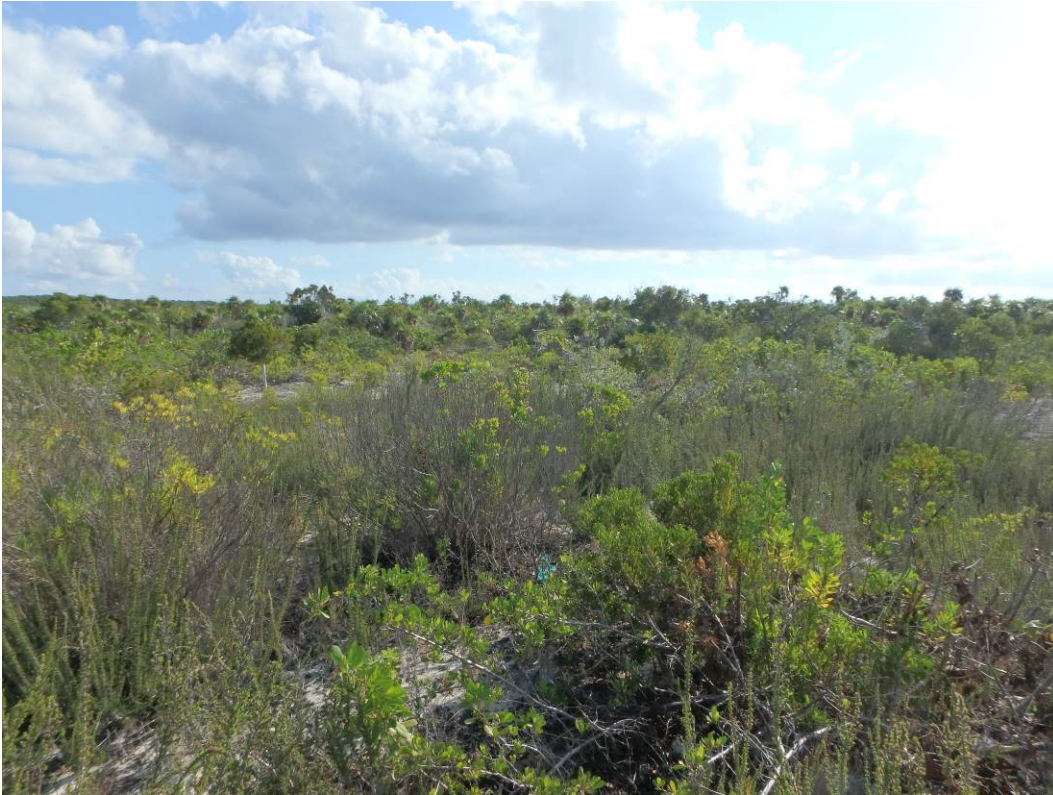
Approximately 22.7 acres (5 percent of the assessment area) consisted of a Sand Strand community, a vegetative community located landward of sandy beaches. Although the diversity of Sand Strand vegetation is naturally very low, vegetation encountered in this community included sea oats (*Uniola paniculata*), silver top palms (*Coccothrinax argentata*), seven-year apple, sea grapes, sea lavender (*Argusia gnaphalodes*), inkberry (*Scaevola plumieri*), beach creeper (*Ernodea littoralis*) and other species that thrive in the deep, and comparatively sterile, sandy soils. Photo 4-25 is representative of this community.

Photo 4-25. Typical Sand Strand Community (December 11, 2022)

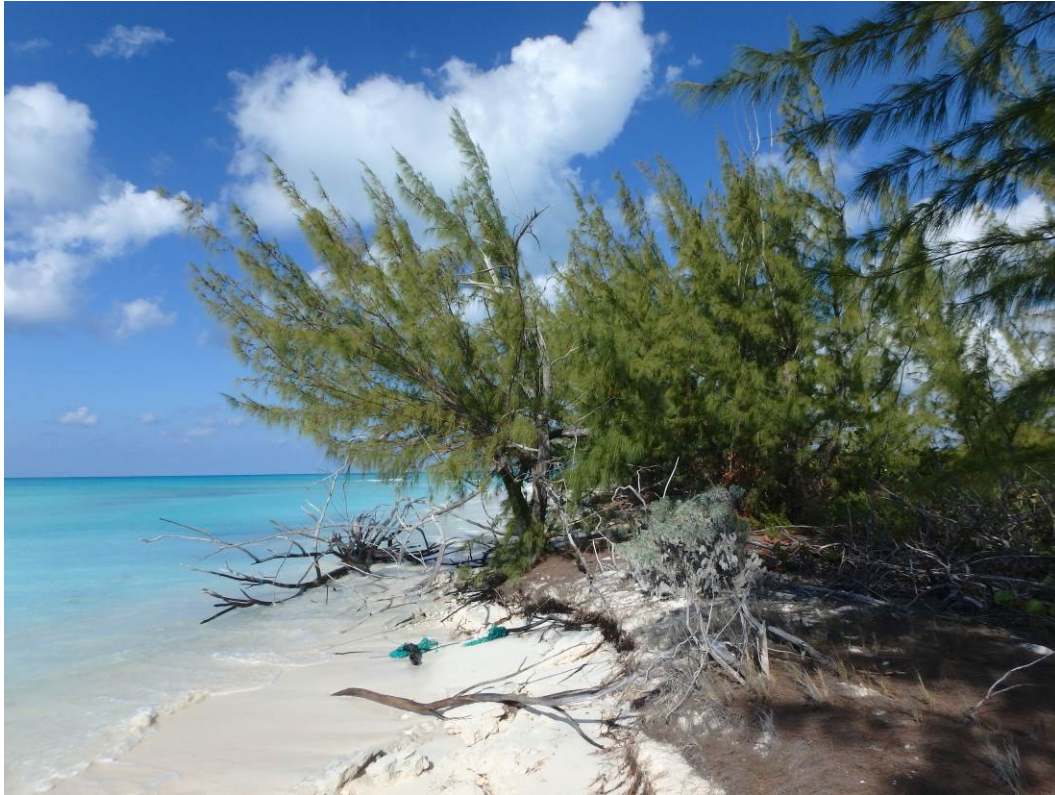
Photo 4-26. Typical Australian Pine Dominated Sand Strand (December 11, 2022)

Approximately 5.5 acres (1 percent of the assessment area) consisted of a *Casuarina*-dominated corridor (Photo 4-26), in the transition zone between the sandy beach and the Sand Strand community. The only location within the assessment area where this non-native pest plant was observed was on the western waterfront. *Casuarina* were present in sufficient

abundance and density that they were having a significant adverse effect on native plant communities.

In these areas, the combination of many years of accumulation of pine needle duff, acidification of surface soils, and decreased sunlight reaching the forest floor have resulted in the gradual loss of native understory vegetation. Analysis of historical satellite imagery suggests that *Casuarina* have been present in this area for at least 15 years. In areas where the *Casuarina* trees have become a pervasive monoculture, native canopy, shrub and groundcover vegetation is non-existent. At several locations along the west-facing beach, erosion had caused the trees to topple (Photo 4-27).

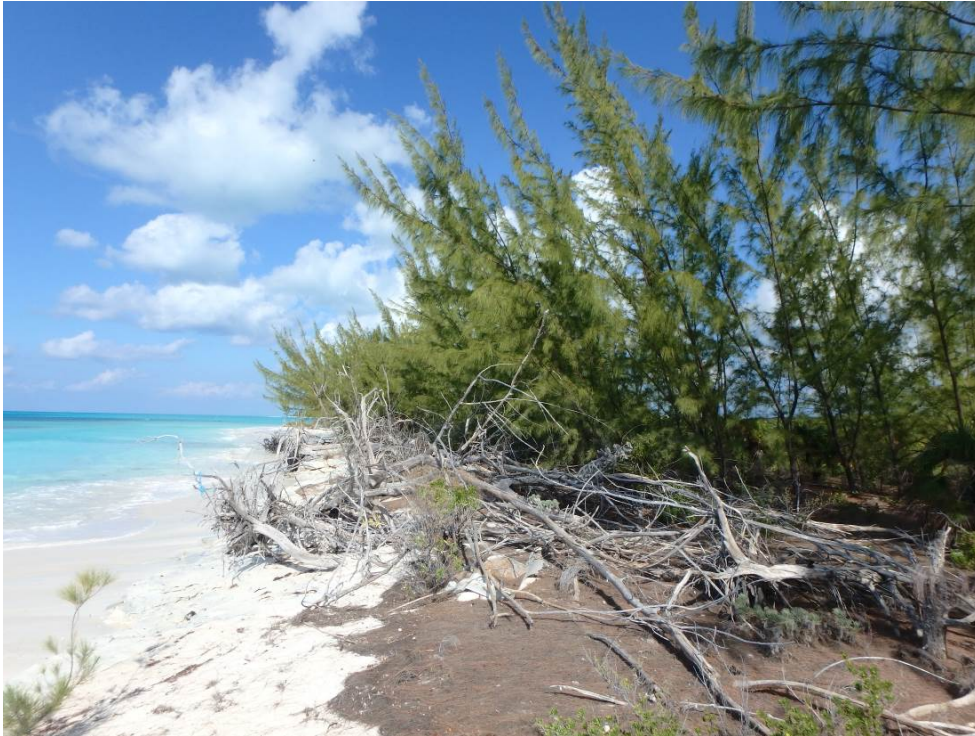
Photo 4-27. Australian Pines Topped due to Beach Erosion (December 11, 2022)

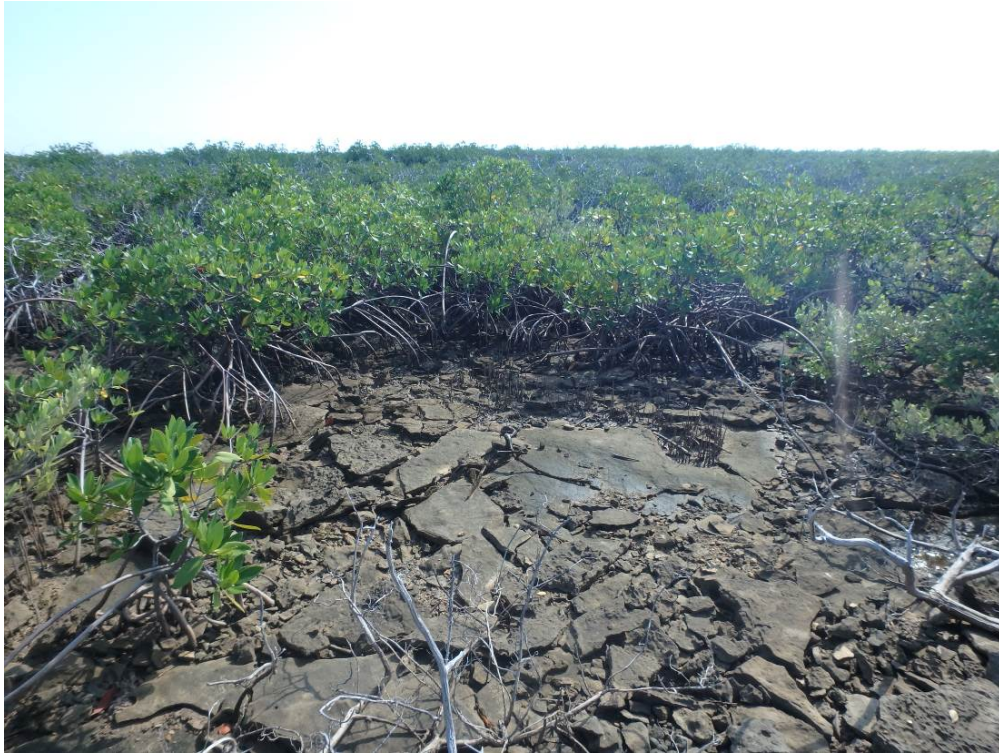
Photo 4-28. Mixed Mangrove Community at Low Tide (December 11, 2022)

Within the southern tip of the project site, approximately 5.7 acres (1.2 percent of the assessment area) was found to be a Mixed Mangrove community (Photo 4-28) that consisted primarily of intertidal red mangroves (*Rhizophora mangle*) nearest to the water and black mangroves (*Avicennia germinans*) and white mangroves (*Laguncularia racemosa*) being present in lower numbers, and in varying stages of maturity, at slightly higher elevations. A tidal creek situated on the west side of this feature (Photo 4-29) appeared to allow tidal inundation of portions of this community. Mangroves near the upper (i.e., northeast) perimeter of this feature appeared stunted, perhaps, in part, due to limited tidal exchange and/or a lesser depth of peat overlying a limerock substrate.

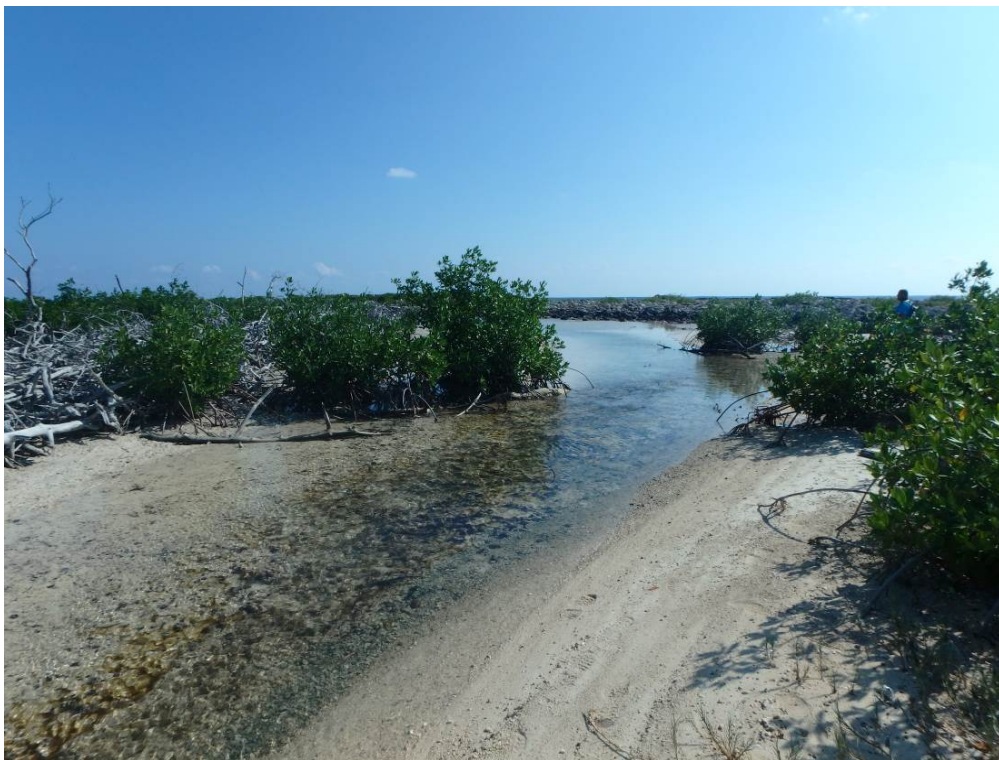
Photo 4-29. Typical Tidal Creek (December 11, 2022)

A narrow, curvilinear mangrove-lined tidal creek (Photo 4-29) approximately 500 ft (about 150 m) in length was found to provide flushing from the sound into and out of the Mixed Mangrove area.

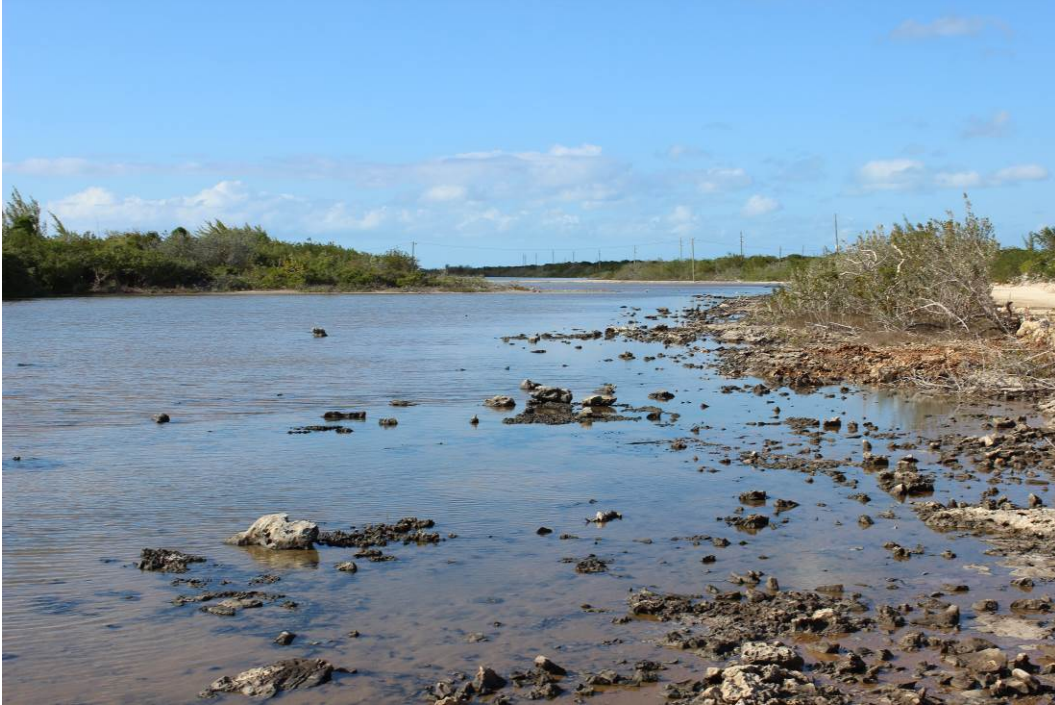
Photo 4-30. Northwest Salina; View Looking North (December 9, 2022)

Three open-water Salinas were present within the assessment area. Two of these were fairly long, narrow, north-south oriented and located waterward (i.e., west) and parallel to an existing unpaved access road in the western portion of the property. It appeared that these ponds may be connected during periods of high water and are the extension of a coastal salt pond complex that stretches over 5 miles (7 km) toward the north, and includes the former Diamond Crystals salt works. No direct connection to the Sound was observed, but at their nearest locations, the western edges of these ponds were less than 200 ft (about 85 m) from the open waters of the Sound. Salinity values in December 2022, were 67 parts per thousand (ppt) for the north pond and greater than 130 ppt for the south pond. The south pond is considerably wider and had a wider area of exposed shoreline at the time of the investigation. Photo 4-30 and Photo 4-31 show conditions in these ponds during the assessment.

From a qualitative perspective, the salinas were rated as Good. Further analysis over a longer period would be needed to determine salinity highs and lows and populations (or lack thereof) of aquatic organisms that might attract flamingos and/or other wading birds. While salinas are largely disparaged due to their odors, bugs, and/or general unaesthetic appeal, they do provide habitat for a variety birds, including nesting habitat for breeding birds (e.g., black-necked stilts and white-cheeked pintails) and wintering habitat for migratory species (e.g., blue-winged teal, scaup) that is not present in other areas of the property. They also provide a measure of coastal resilience, as they are accustomed to highly variable water and salinity levels.

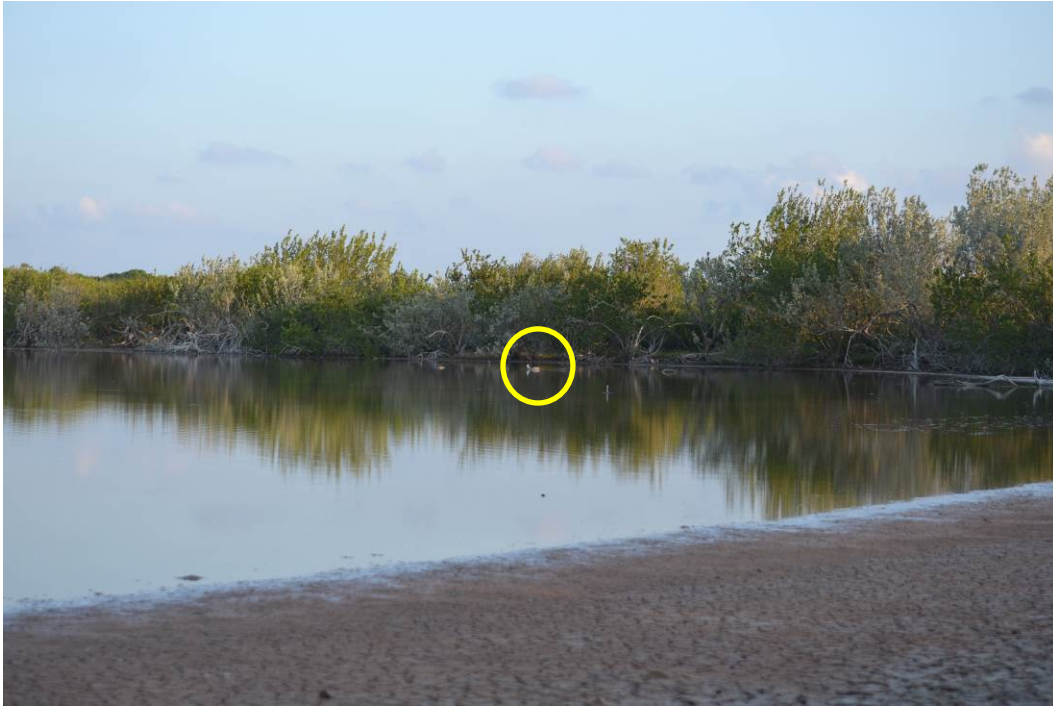
Photo 4-32. Yellowlegs Foraging along Southern Shore of Northeast Salina (December 10, 2022)

A third salina, generally rounder in shape, was found to be present to the east of the access road near the north boundary of the property. A rock wall, likely a former property boundary, extended from the road to the western edge of the pond. Lesser yellowlegs were observed foraging near the southwestern shoreline of this pond, which had a salinity of 51 ppt on December 9, 2022 (Photo 4-32).

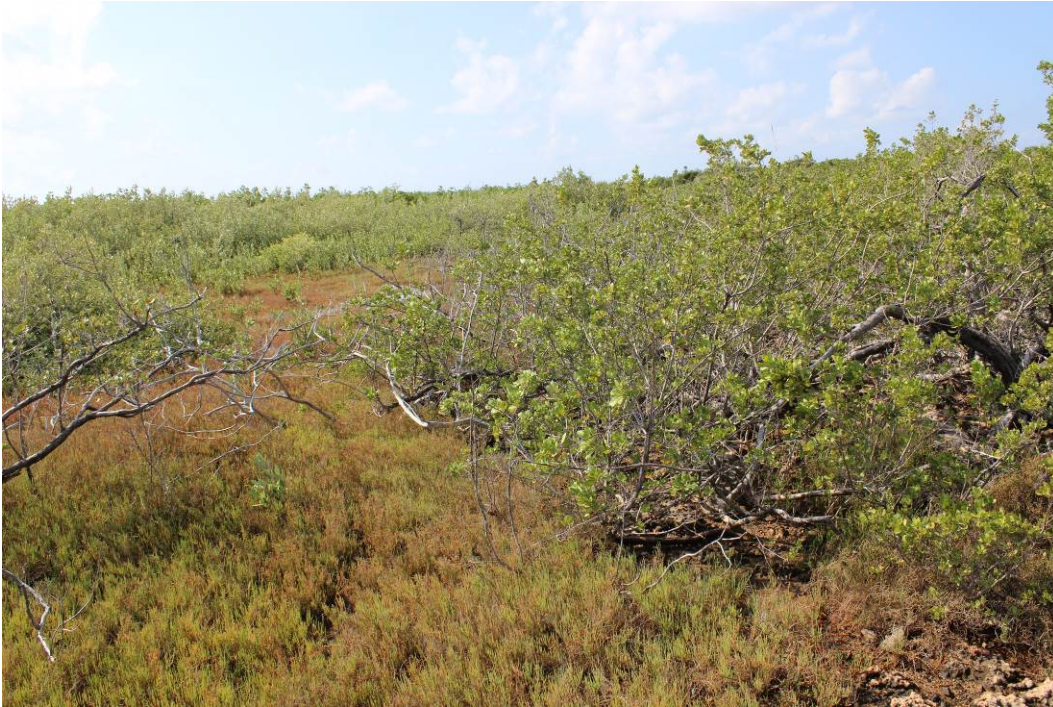
Photo 4-33. Woody Glasswort in Estuarine Herbaceous Habitat (December 10, 2022)

One small (0.5 acre) area of estuarine herbaceous habitat was located along the northeastern perimeter of the Mixed Mangrove area in the southern part of the assessment area (as noted in Section 4.7.1.2). Woody glasswort (*Sarcocornia virginica*) was the dominant vegetation in this area (Photo 4-33), although in some areas, it was a groundcover species under a sparse *Conocarpus erectus* shrubland.

From a qualitative perspective, the Estuarine Herbaceous habitat was rated as Good. Further analysis over a longer period would be needed to determine salinity and water fluctuations, but the presence of wading birds suggested this area likely provided habitat for crabs and other species of wading bird prey that may not be present in other areas of the property. This wetland habitat also provides a measure of coastal resilience, as it is accustomed to highly variable water and salinity levels.

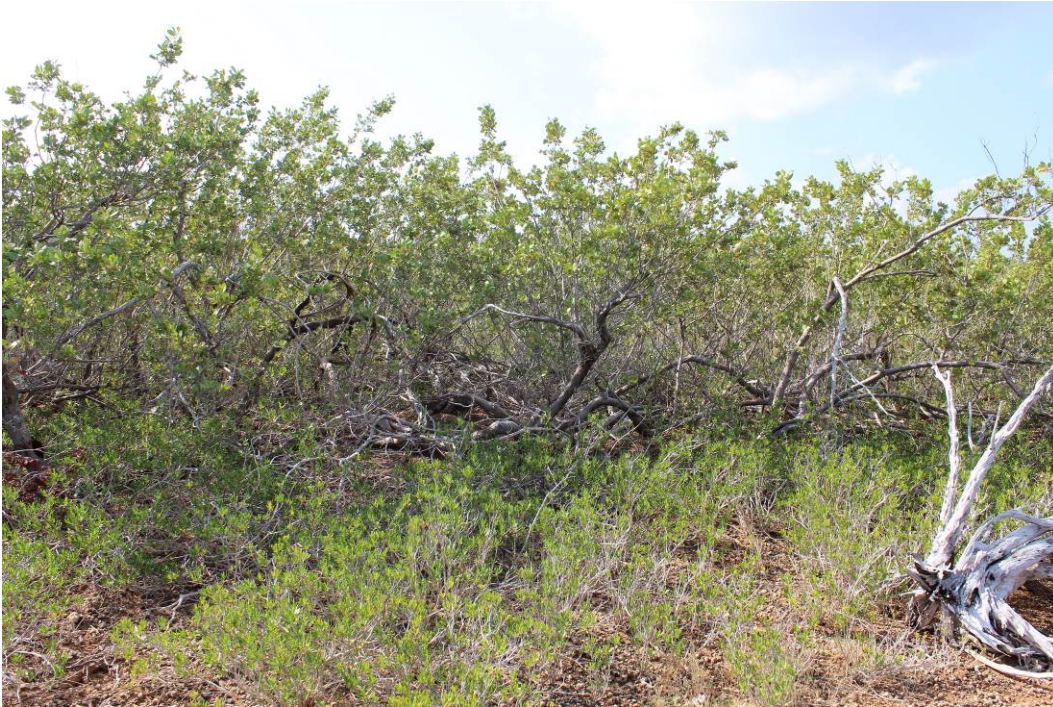
Photo 4-34. *Conocarpus erectus* (December 10, 2022)

Although not a habitat identified in *A Guide to Caribbean Vegetation Types* (Areces-Mallea, 1999), several near monoculture stands of buttonwoods were different enough from surrounding areas that they warranted a separate designation. Trees were mature, but varied considerably in height, based on the thickness of soil overlaying the rock substrate. At locations where the mucky soils were thickest, trees were in excess of 20 ft (3 m) in height. In areas where they were growing directly out of the rock, they were frequently less than 3 ft (1 m) in height.

Buttonwoods are considerably more tolerant of wide ranges of water levels and soil salinity than most other tree species, which explains their frequent presence along the edges of salt ponds. Both green buttonwoods (Photo 4-34) and silver buttonwoods, which are frequently used as a landscape species, were common.

From a qualitative perspective, the *Conocarpus* stands were rated as Good. While this community has very low biodiversity, it provides a valuable function in resiliency to changes in water level. Even when flooded for extended periods of time following hurricanes or other tropical storms, *Conocarpus* frequently survive by growing adventitious roots that allow their survival until water levels subside to “normal” levels.

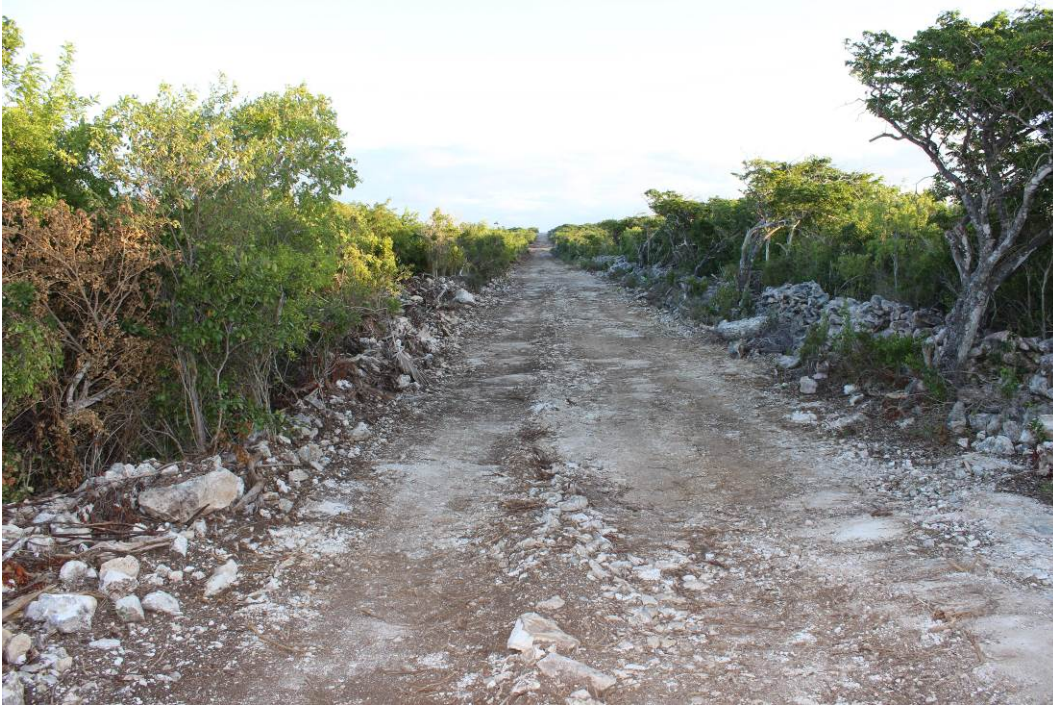
Photo 4-35. Typical Unpaved Road (December 9, 2022)

Several areas of the site consisted of cleared, but unpaved roads (Photo 4-35).

Several of these roads had been apparently cleared, or recently re-cleared before the December 2022 field assessment. Additionally, an east-west oriented, previously cleared area near the northern boundary had reportedly been cleared as a landing strip during the drug-smuggling era in the 1980s.
