*ENVIRONMENTAL IMPACT ASSESSMENT
CALYPSO COVE
LONG ISLAND, THE BAHAMAS*

JULY 2023

**ISLANDS
BY DESIGN**

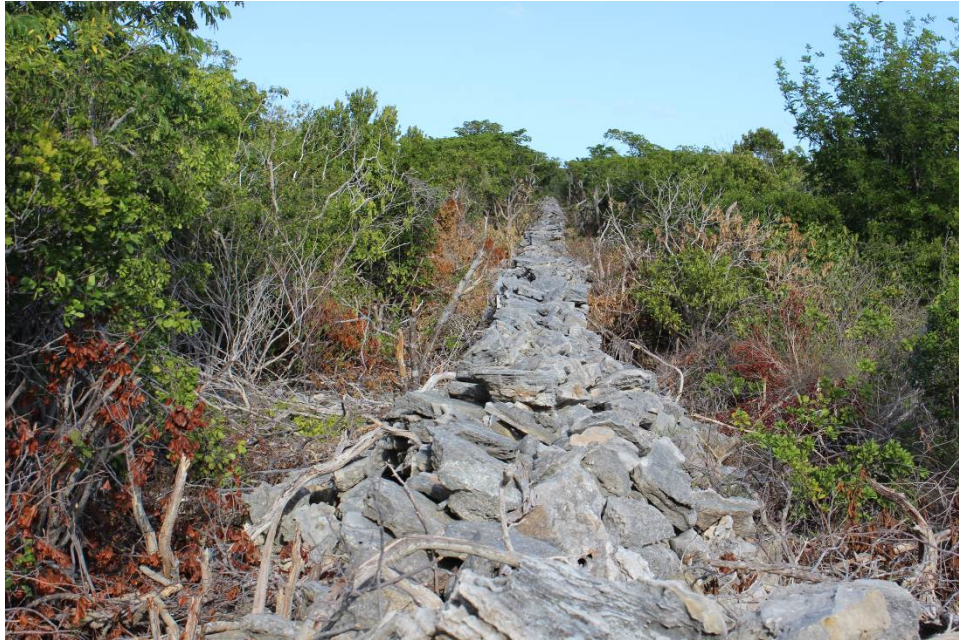
Photo 4-36. Typical Rock Wall (December 9, 2022)

Rock walls, made of local limestone rock and generally 3 to 4 ft in height and approximately 6 to 7 ft wide at the base (Photo 4-36), were present along several property boundaries.

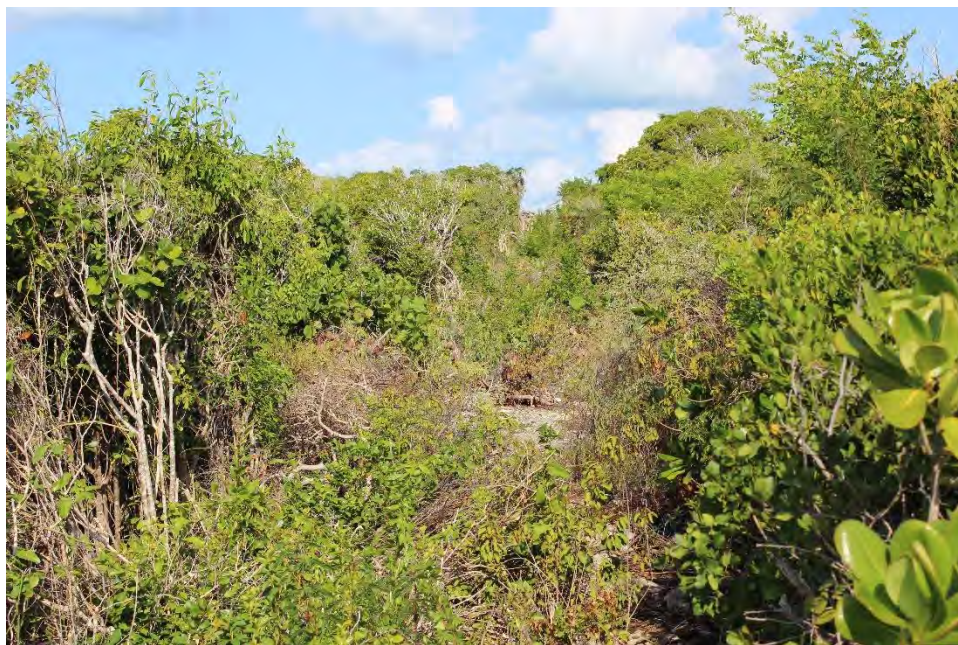
Rock Wall along a Property Line, Being Reclaimed by Dry Broadleaf Evergreen Forest,
View Looking Northeast

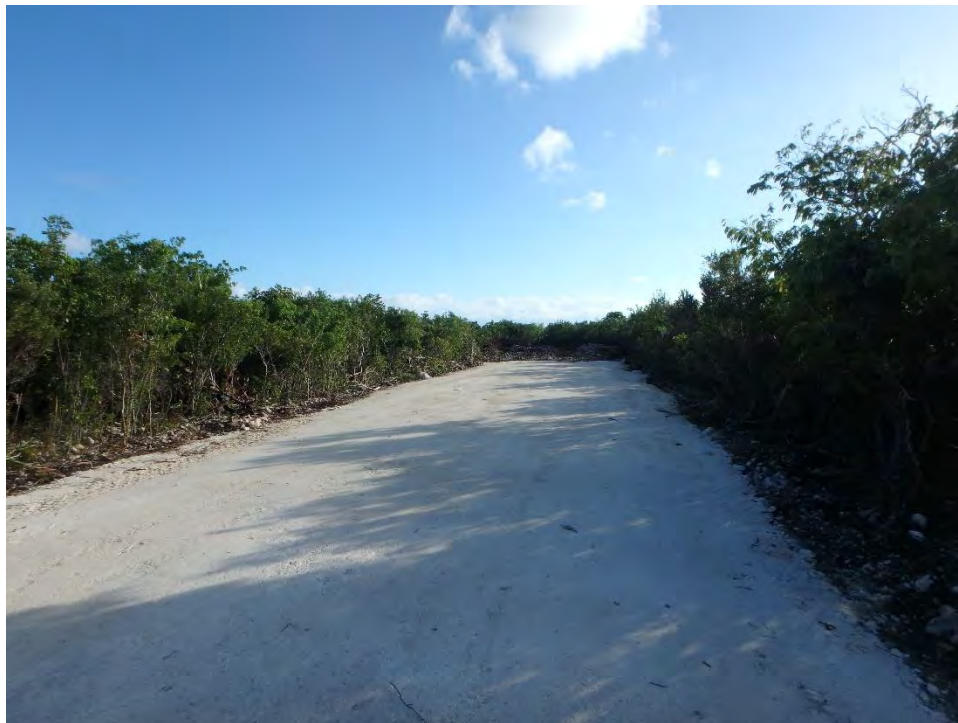
Former Landing Strip, Recently Resurfaced, View Looking East-Southeast

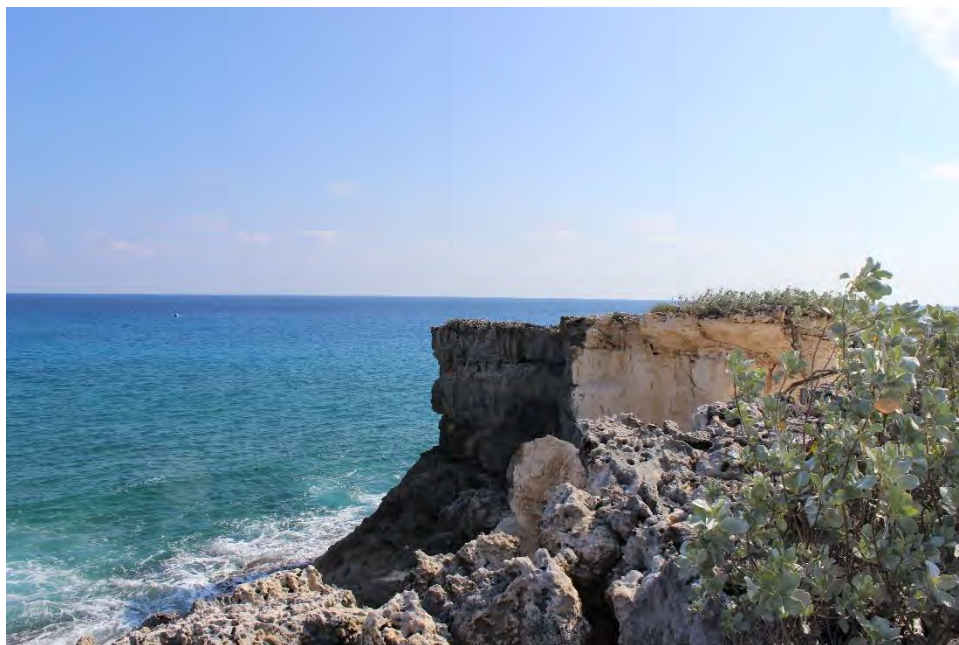
Steep Coastal Rock Bluff, Eroded, on Southeast Coastline

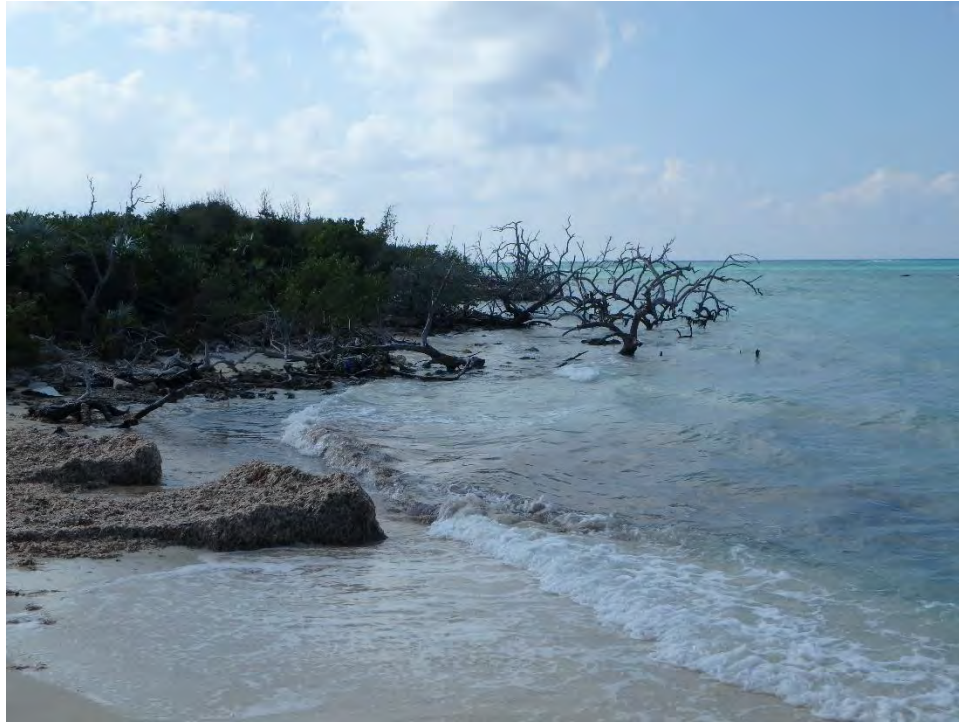
Heavily Eroded Shoreline along Southern Portion of West-Facing Shoreline

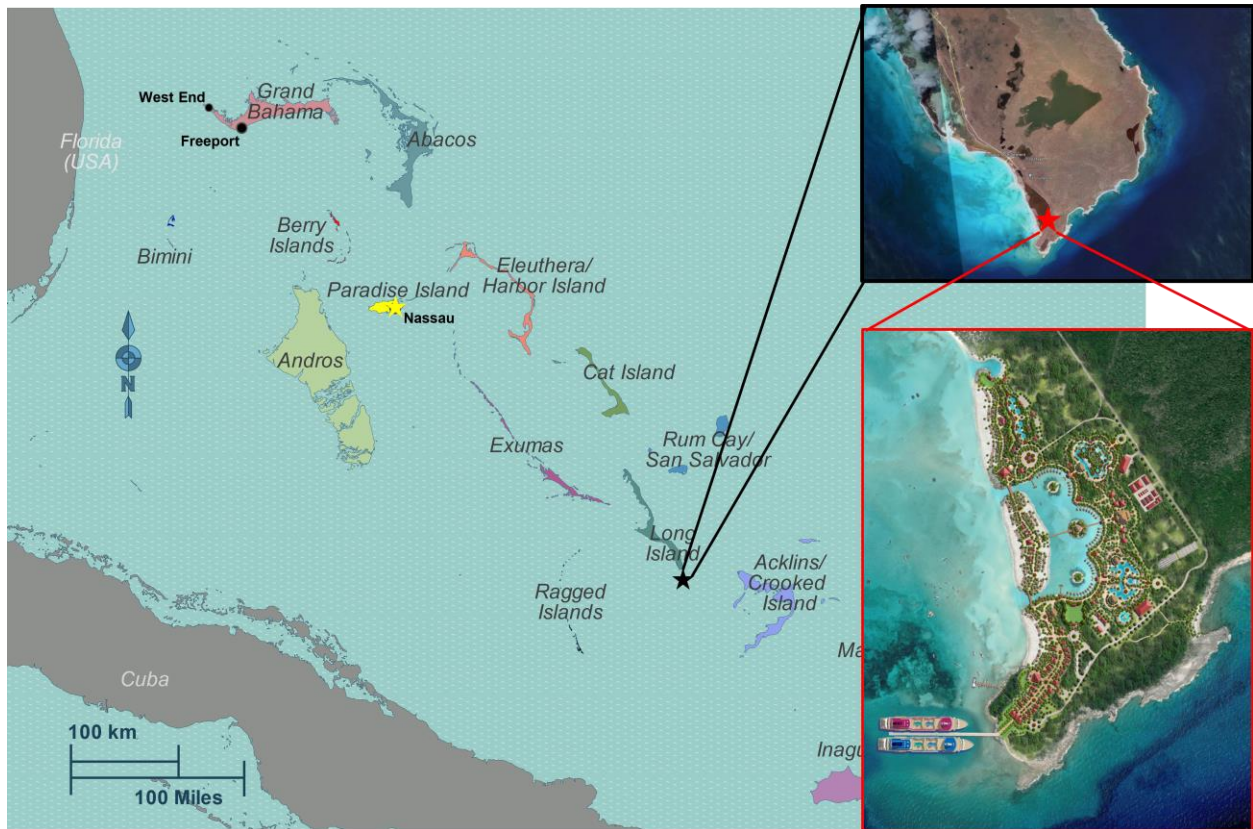
FIGURE 1: PROJECT LOCATION WITH PROPOSED LAYOUT

The Project site is located at the southern end of Long Island, The Bahamas and includes a proposed inland lagoon adapted from an existing salt pond as illustrated in Figure 1.

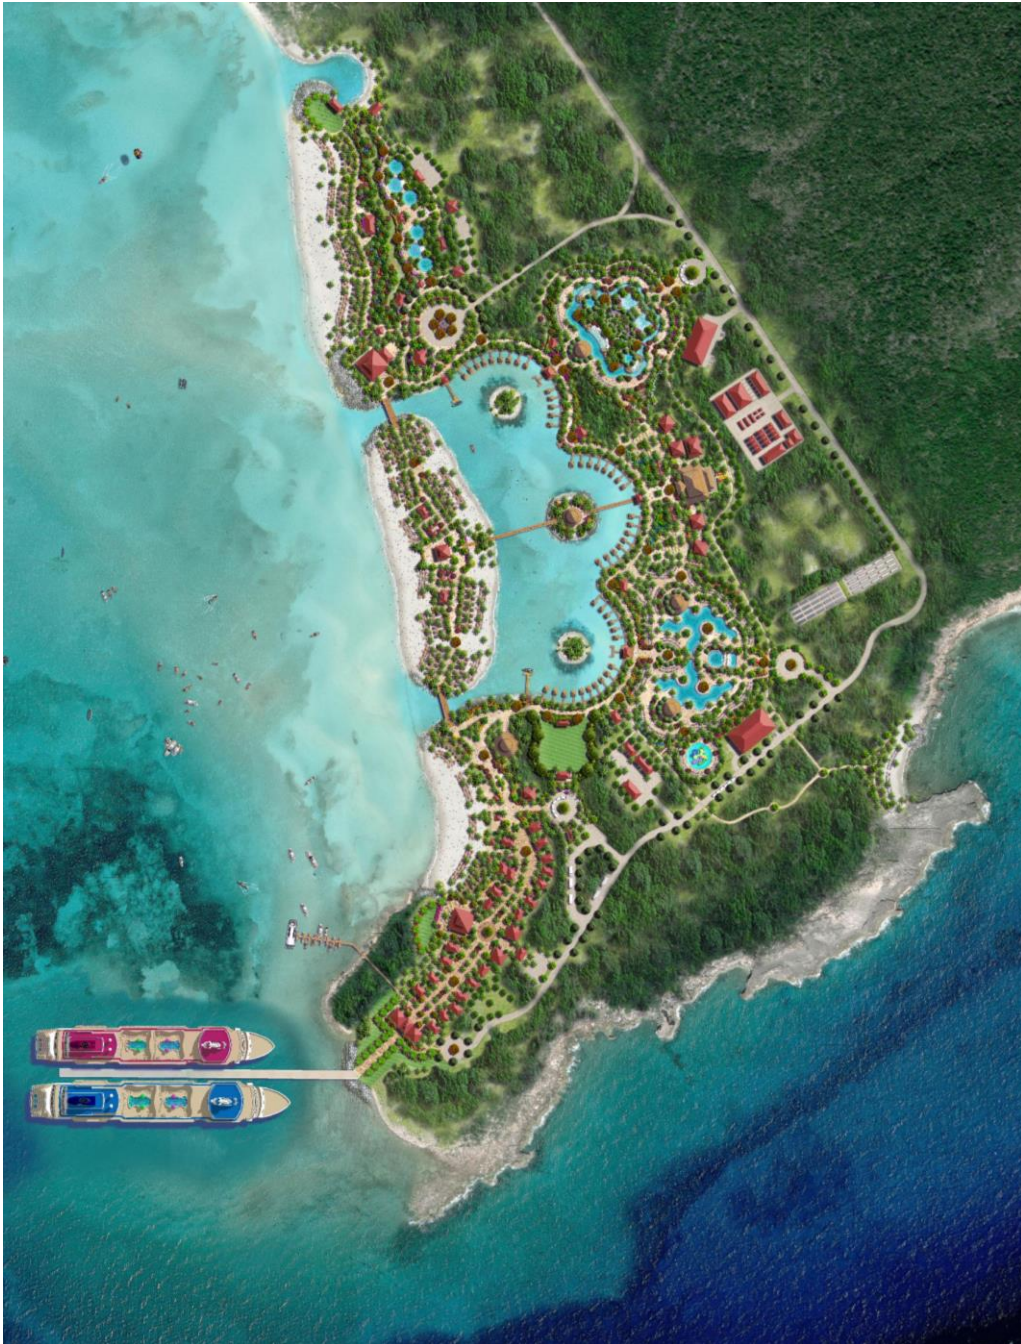
FIGURE 7: PROPOSED LAGOON LAYOUT

The proposed Project involves constructing an inland lagoon spanning approximately 1,000 feet of shoreline. The lagoon design features two navigation channels, each with a maximum width of around 65 feet (20 meters) and a length of 330 feet (100 meters). Inside the lagoon and channels, the water depth was set at 8 feet (2.4 meters) above mean sea level (MSL), with the channels extended to the nearest contour of the same water depth. To simulate the hydrodynamics of the proposed marina installation, the digitized layout was integrated into the existing numerical model. Figure 7 provides a visual representation of the proposed lagoon.

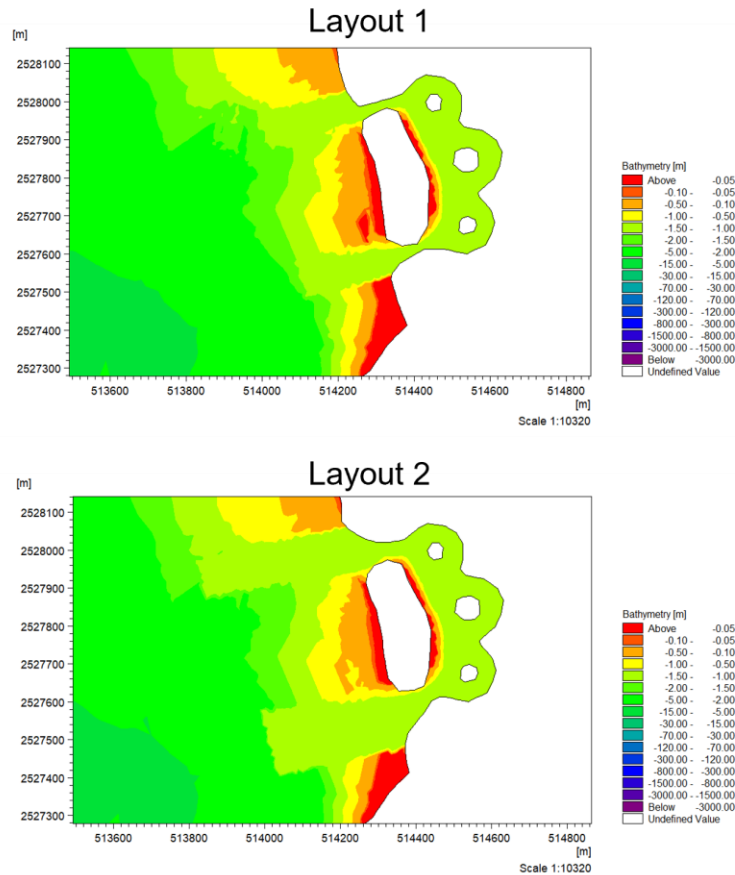
In Layout 1 the volume of water within the lagoon was reduced by 25% through a decrease in water depth, and the flushing times noticeably improved. The results showed a 50% reduction in flushing time, with the dilution reaching 10% of its initial concentration within 48 hours. Figure 11 exhibits the achieved dilution at various time steps during the model simulations for Layout 1.

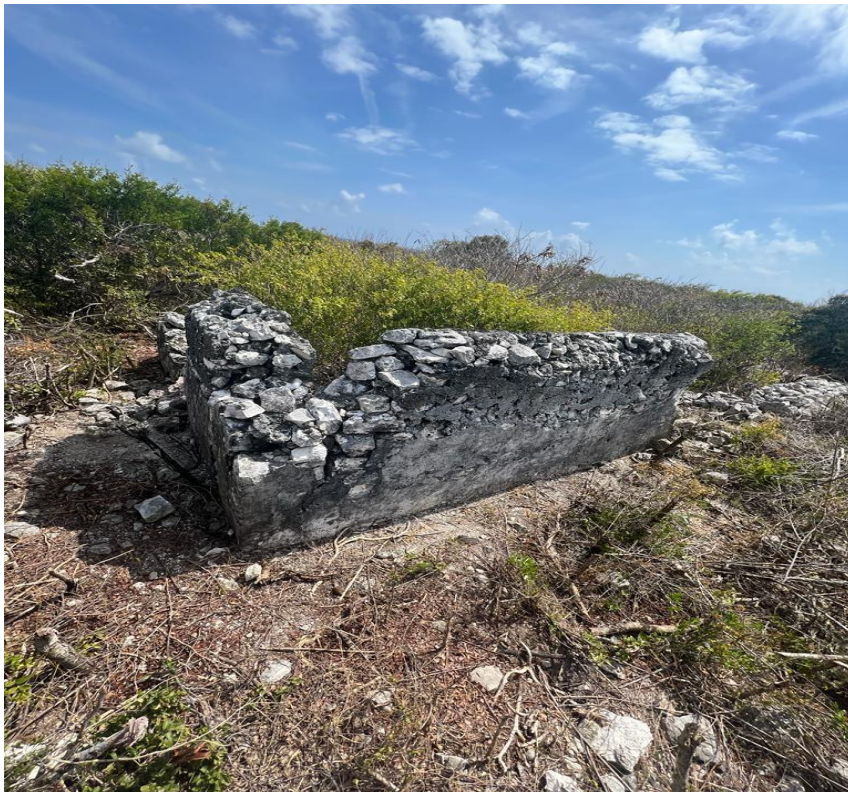
Figure 8: Building Structure in Palm Villa

The Buildings comprise the remains of two dilapidated buildings. The first is at least four times as large as the second, and they both are missing their roofs and most of their walls. We are informed by members of the Watson family that the larger structure was inhabited by Constance Watson and her husband, Louis P. Knowles Sr. after their marriage, and that the smaller structure was possibly an outdoor kitchen. Another member of the Watson family told us that the larger structure, or possibly another structure that has not yet been located, was once used as a church. No other person interviewed has shared a similar narrative.

The Buildings fall under the heritage asset category of “sites and places”. Sites and places are areas that have connections to a specific person, activity or event, or that incorporate multiple elements that collectively tell a particular story or illustrate the passage of time. This can include archaeological assets that incorporate the remains of previous human interventions into the landscape. These assets will often be incomplete, but were once permanent structures, as is the case with the Buildings.

In the 1800s and before, roofs in The Bahamas were also frequently constructed out of wood shakes, or wood shingles. Wooden shingle roofs were prevalent during that period in the North American colonies, as wood was plentiful there as compared to England, where timber was a scarcer resource. (Cement tiles became the most frequently used roofing material in England at the turn of the 19th and 20th centuries, when their production was automated.) Wood shakes were often imported into The Bahamas from North America. It is likely that, given the social prominence of the Watson family in Long Island, the roofs of the Buildings were fashioned from wood shakes rather than thatch.

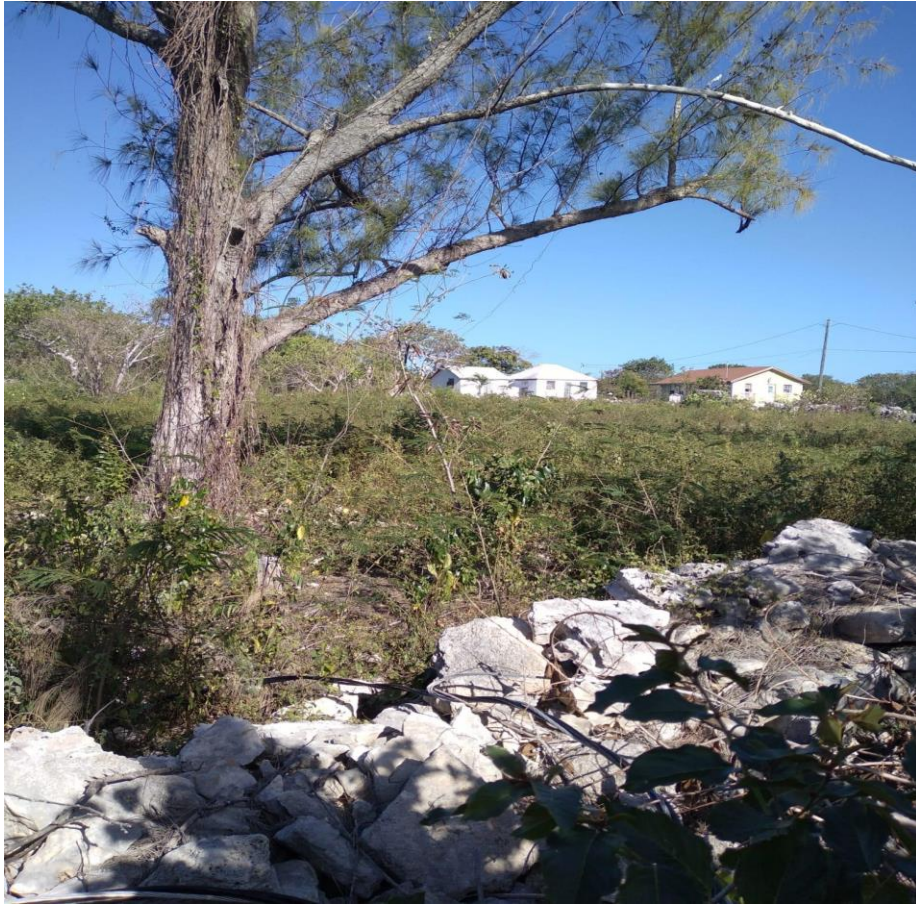
Figure 10: Similar buildings in Long Island

We have not been able to locate any images of the Buildings while they were still standing. We did receive a photograph from a member of the Watson family, of houses in the Gordons settlement that are said to have been built around the same time and to share a similar construction to that of the larger of the Buildings. They have, of course, undergone renovations over the years. We have included this photograph for illustrative purposes:

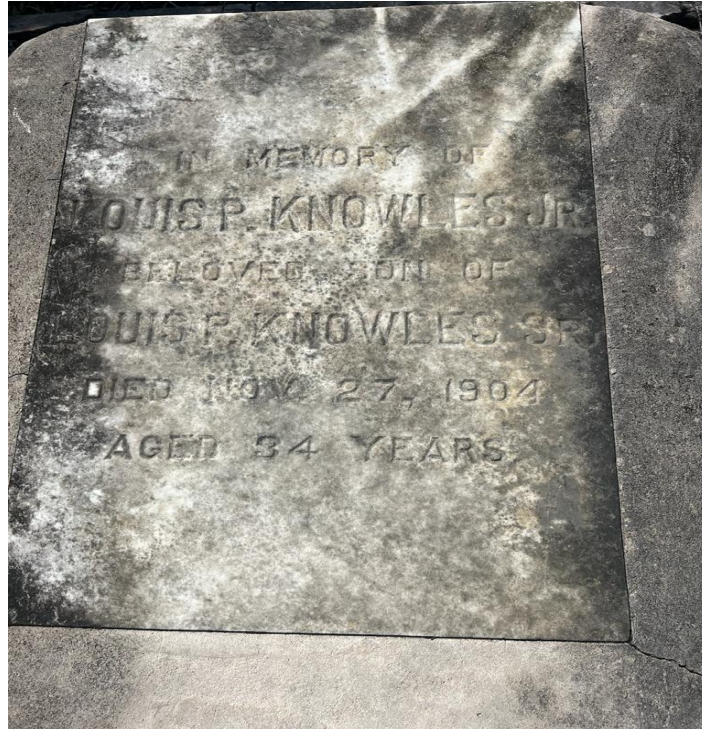
Figure 11: Gravestone with inscription

The Gravestone is a reasonably large, weathered concrete structure that is well-preserved and in relatively good condition. It is engraved with standardized lettering that is still legible, and is located a few metres away from the Buildings. A Watson family member informed us that there is a second gravestone on the property, but we have not had sight of the same.

The Gravestone falls under the heritage asset category of “Structures”. Structures are man-made constructions other than buildings that are not usually used for habitation. They may be practical in form and function, solely decorative, or a combination of both. Structures include headstones and gravestones, as well as other constructions like bridges and piers and boundary walls (to be considered below). They typically have architectural and historical illustrative value, as well as aesthetic/artistic value (the visual and experiential qualities of a site or structure).

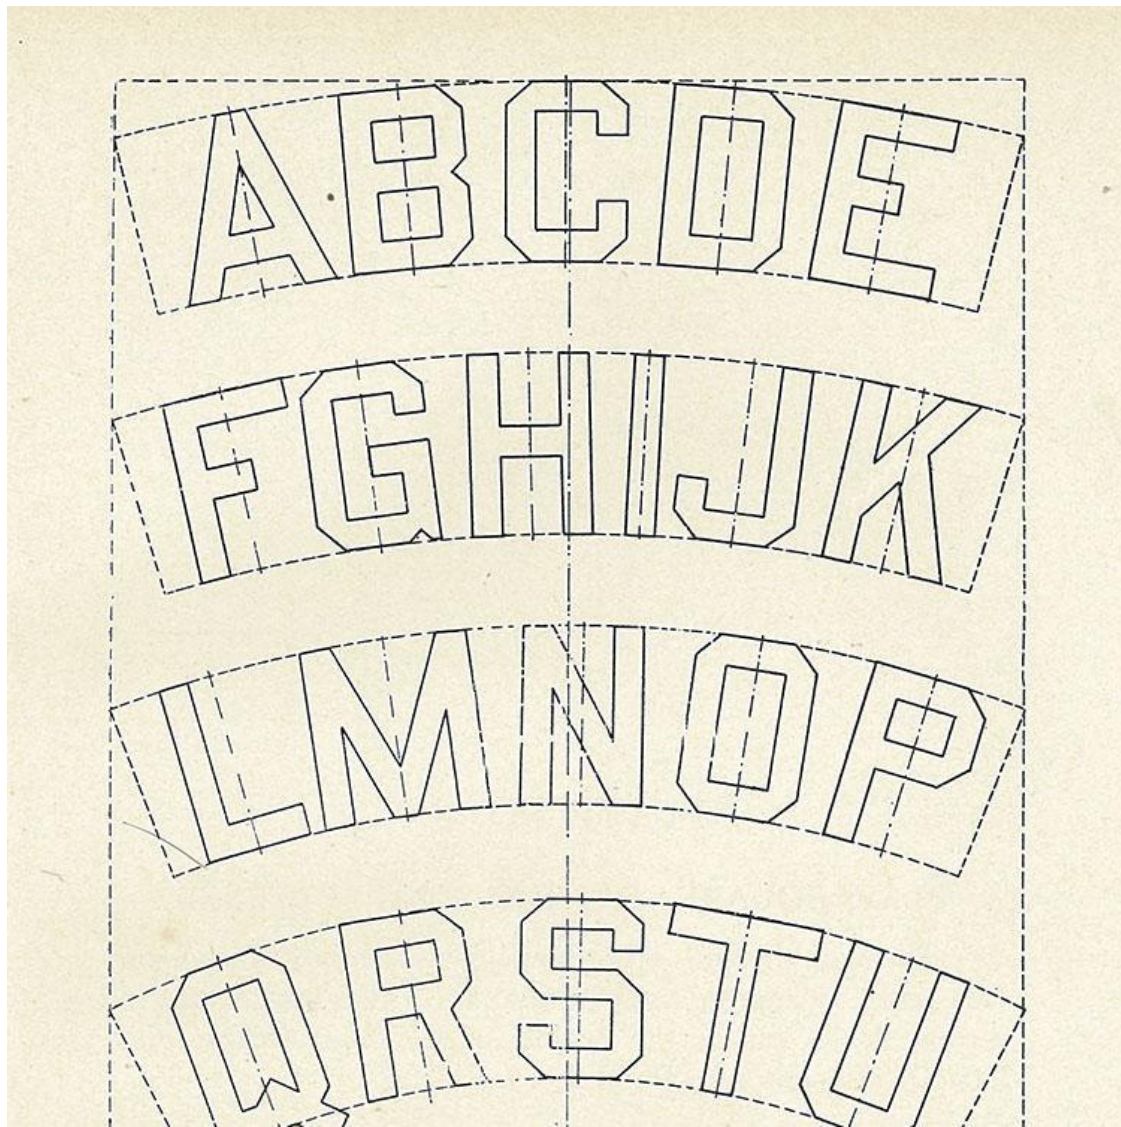
Figure 12: Photo of FA Church's lettering style

The early 1900s saw the increased standardization of monument lettering styles, and these styles began to be more thoroughly documented and distributed through articles in trade publications, the creation of lettering plates, and the printing of lettering books. One of these standardized styles was created by F. A. Church, who began his Practical Lettering for Memorials column in the American Stone Trade magazine between 1912 and 1915, with the intent of educating the industry on a mechanical process to allow less skilled draftsmen to lay out lettering without freehand drawing.

We note that F. A. Church's lettering style is remarkably similar to that of the Gravestone and it is possible that Church's lettering plates were used to engrave the Gravestone.

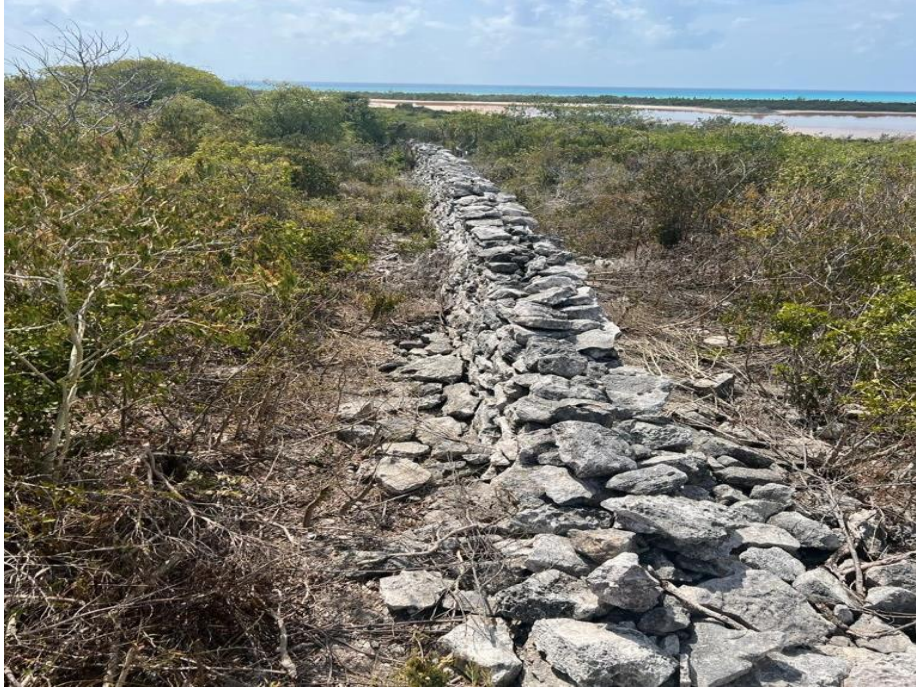
Figure 14: Boundary Wall in Palm Villa

Running the length of the property and beyond is a low wall, about 3-4 feet high, made of stacked stones, and crumbling in sections. Walls like it are ubiquitous in the island and form part of the natural landscape. Globally they are referred to as dry stone walls, and are known locally as "lime

walls”, or “slave walls”. These walls are not unique to Long Island, but are found on a number of Family Islands.

Like the Gravestone, the Wall falls under the heritage asset category of “Structures”. They are practical in form and function, and like other such structures, have architectural, historical illustrative, and aesthetic/artistic values.
